**T.S.B. No: RE001s**

**Product: STARTER MOTOR**

**Make:** FORD  
**Model:** FORD 2.0 / 2.4 Diesel  
**Part No:** VS801  
**Subject:** Starter Motor Failure

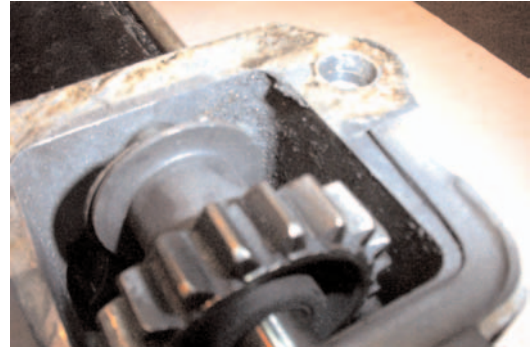
Fig.1 Fine metal particles from Dual Mass Flywheel, clutch dust contamination of the pinion and drive assembly.

On inspection of the units, we have found that the motor pinion shaft and motor magnets are heavily contaminated by a high level of fine metal dust and clutch dust. (See fig.1)

This is due to a gradual failure of the Dual-Mass Flywheel, which causes fine metal dust to impregnate the pinion/drive area and motor magnets. This results in the following symptoms: - Clicking solenoid but doesn't engage, or intermittent starter operation.

This is not a fault of the starter motor but as a direct consequence of the metal dust contamination. If the original unit displays build up of fine metal dust around the pinion area on removal, any replacement starter motor will fail in a short period of time if the cause of the original is not rectified and the transmission bell housing is not thoroughly cleaned.
